Beach Renourishment in Jacksonville

Steven C. Howard, P.E., D.CE

Kevin R. Bodge, P.E., Ph.D.

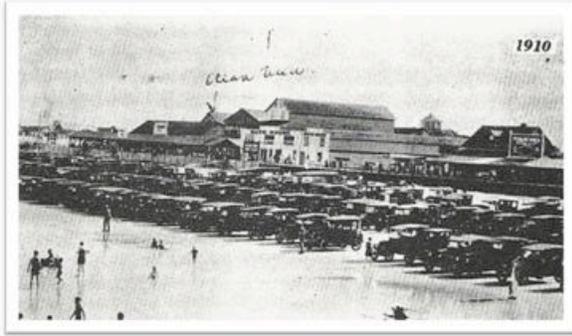
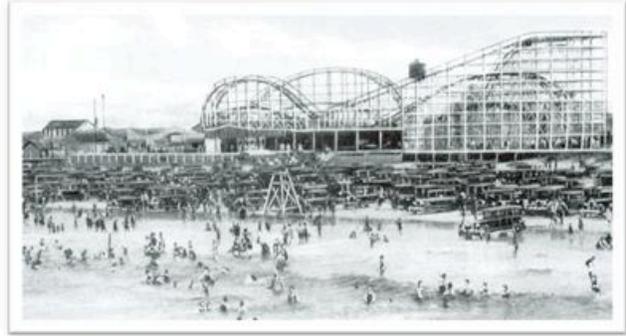
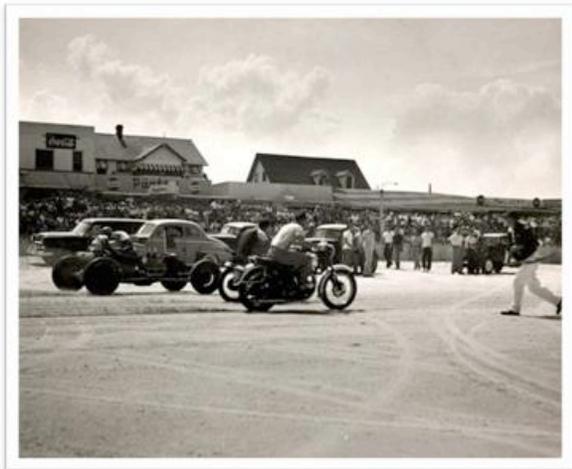
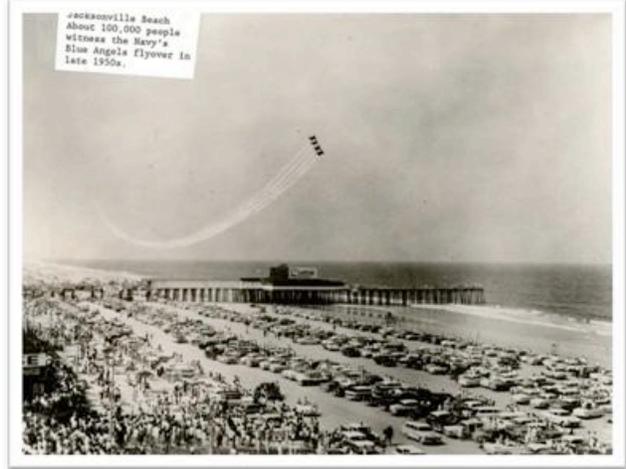
Figure B: Shortly after the expansion of the railroad into Jacksonville Beach and the construction of Atlantic Blvd. (Florida's first paved highway) the beaches became a major recreational destination. *<upper left>* c. 1910. *<upper right>* The boardwalk along Jacksonville Beach, c.1920-30. *<lower left>* Easy road access to the beaches made auto racing a popular activity. *<lower right>* The Blue Angels at a 1950 air show in Jacksonville Beach. Note the seawall/bulkhead fronting the first row of buildings in the 1910, and subsequent, photographs.

The beaches of Duval County, along Florida's "First Coast", enjoy a long and rich history that has been heavily influenced by coastal construction. There are about 16 miles of ocean beaches in Duval County, divided by the St. Johns River Entrance (**Figure A**). The six miles of beach north of the river are part of a large expanse of public parks and remain mostly undeveloped. In contrast, the ten miles of beach south of the river are mostly developed and urban in nature. These include the 1.0- and 1.5-mile shorelines of the Mayport Naval Station and City of Jacksonville's Hanna Park, closest to the river entrance, and 7.5-miles of urban shoreline referred to collectively as "The Beaches". From north to south, this includes the Cities of Atlantic Beach, Neptune Beach, and Jacksonville Beach. These three local governments maintain separate budgets and governance but each share common services with the City of Jacksonville via an intra-local agreement. For more than 100 years, the beach cities have been an important and heavily utilized recreational amenity for the citizens of Duval County (**Figure B**).

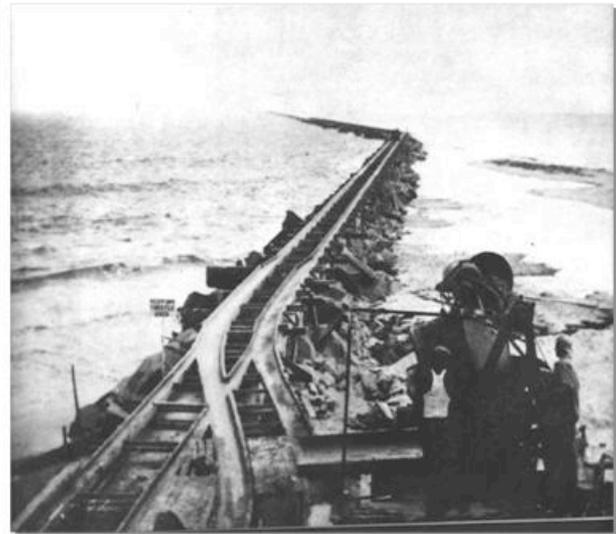
Figure C: Construction of the jetties at the entrance to the St. Johns River, 1880 through 1895. Foundation boulders were placed by barge and the jetty construction was completed by rail.

The Duval County coastline has been profoundly changed by navigation improvements built at the St. Johns River Entrance. These include construction of two rock jetties by the U.S. Army Corps of Engineers beginning in 1879 which were subsequently sand-tightened in the early twentieth century (**Figure C**). The length of the north and south jetties is about 3 miles and 2.5 miles, respectively. As a result of sand impounded against the north jetty, the natural inlets north of the River Entrance have shifted north and one has nearly closed, and new islands have formed and overlapped old ocean shorelines. On the other hand, the jetties -- combined with persistently deeper channel dredging and the resulting changes to the ebb tidal shoal -- act as a littoral barrier that deprive the southern beaches of their natural sediment supply and have caused The Beaches to erode. This erosion, probably combined with imprudent development upon the natural dunes, prompted coastal residents and businesses to construct timber bulkheads as early as the 1910's and 1920's during the Florida land-boom. After storms in 1925 and 1932, most of these bulkheads were replaced by concrete seawalls (**Figure D**). Widespread coastal armoring combined with a chronic sediment deficit resulted in a gradual deflation and narrowing of the beach profiles throughout southern Duval County, from the 1920's through the 60's and 70's (**Figure E**). The nor'easter of 1962 -- followed by the passage of Hurricane Dora in 1964 -- extensively damaged the beaches and coastal communities (**Figure F**). The Corps began placement of sand dredged from the River Entrance to the 1-mile shoreline of Mayport Naval Station, just south of the inlet, in 1963. But the coastal damage was severe enough to warrant congressional authorization of the Federal Shore Protection Project along the entire southern 10 miles of the Duval shoreline, south of the St. Johns River Entrance.

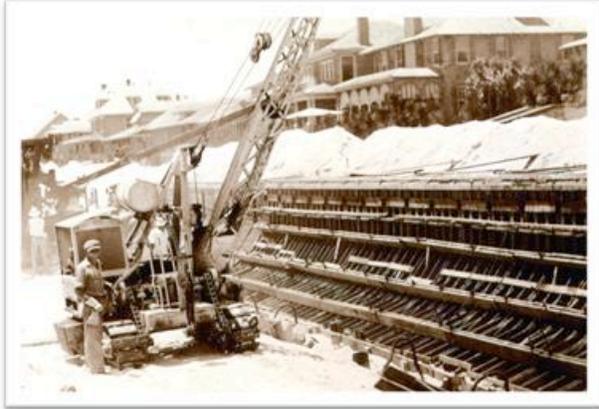
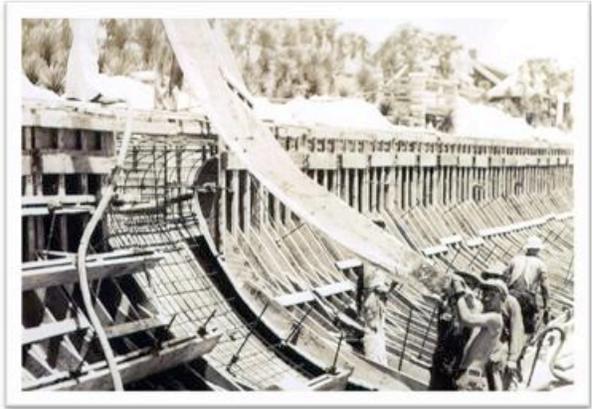
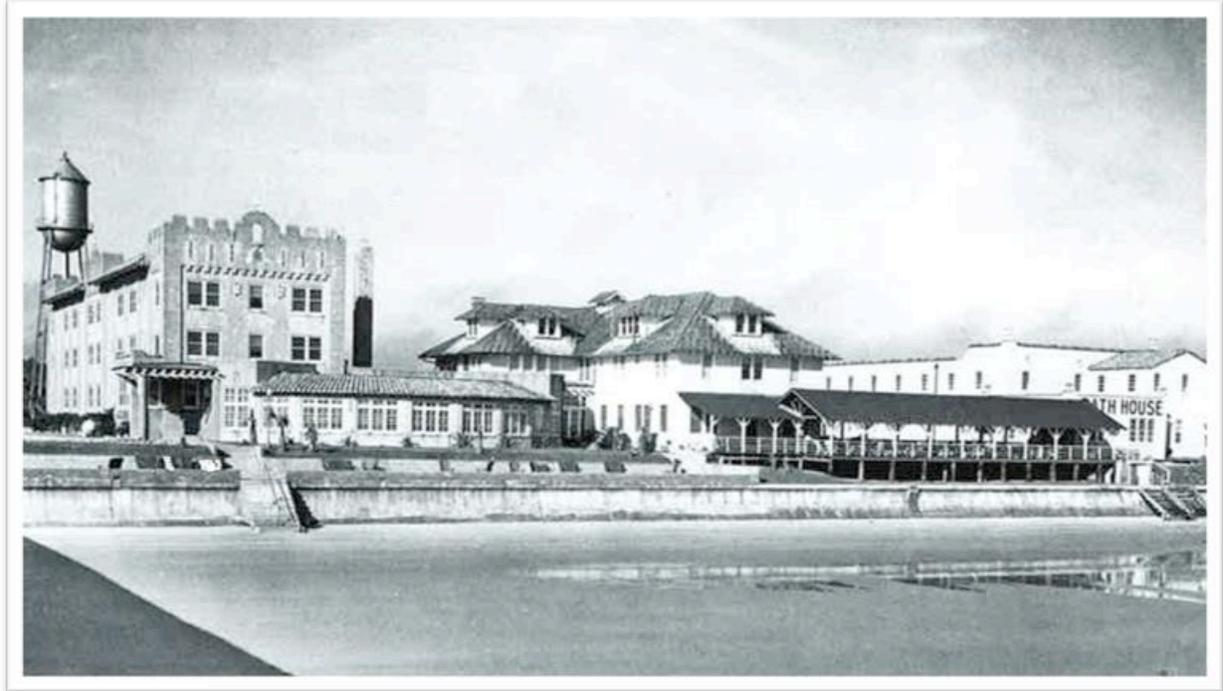
Figure D: Seawall construction along Atlantic Beach in the 1930's.

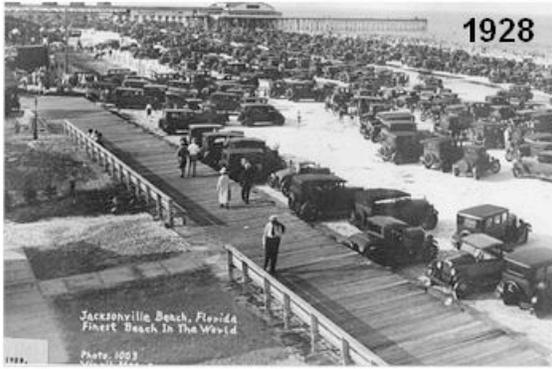
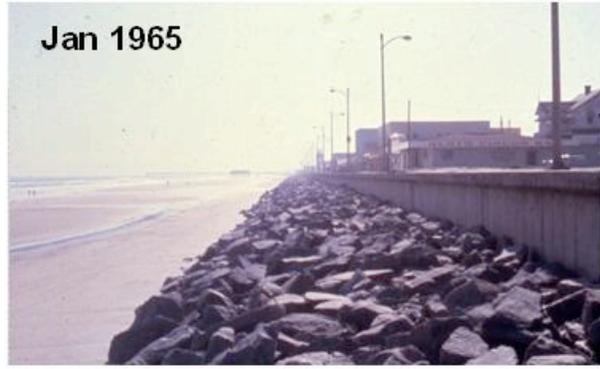
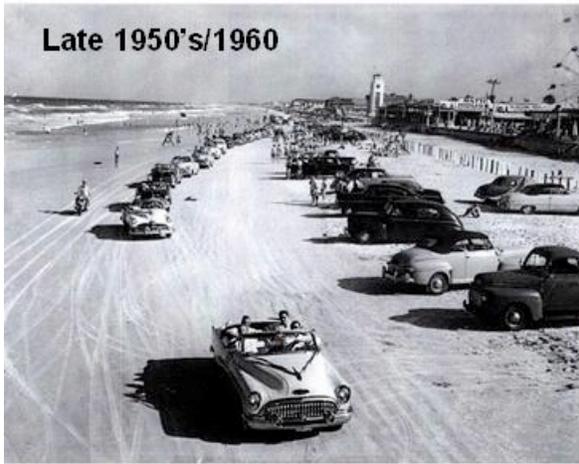
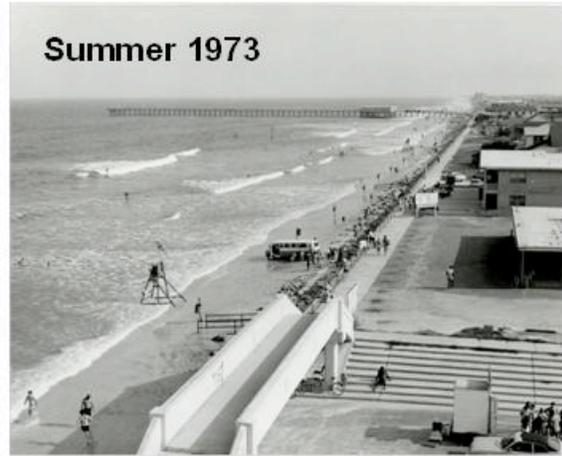
Figure E: Construction of the jetties at Mayport contributed to a lack of sediment supply for the downdrift (south) beach leading to a gradual lowering and contracting recreational beach. The problem was readily apparent by the early 1960's and continued until the initial nourishment project in 1978.

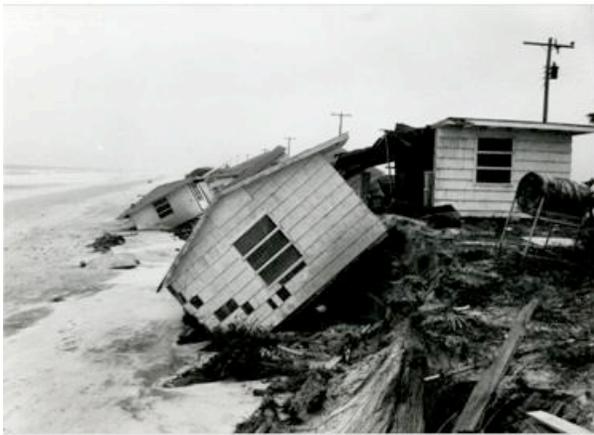
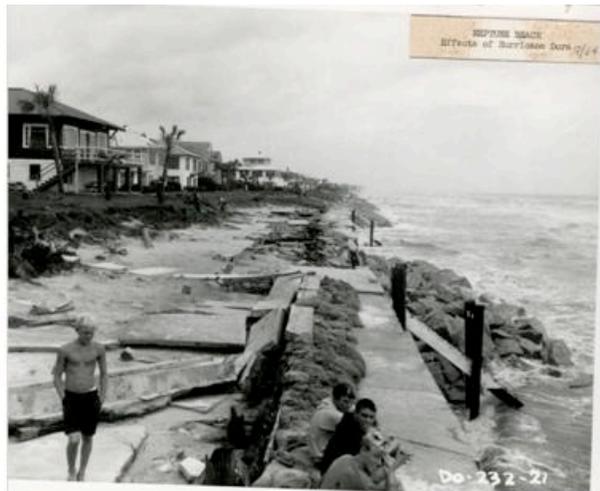
Figure F: Typical storm damage from the 1962 nor'easter and Hurricane Dora, 1964.

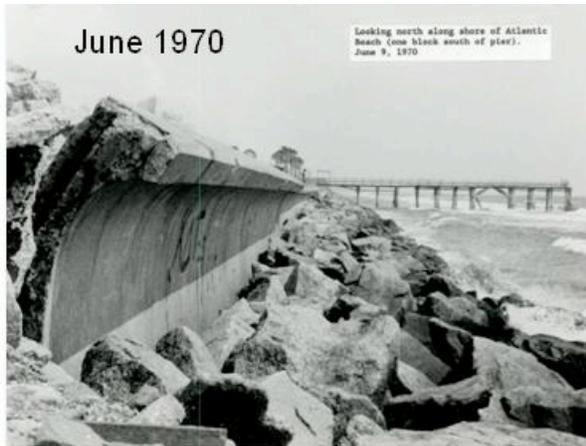
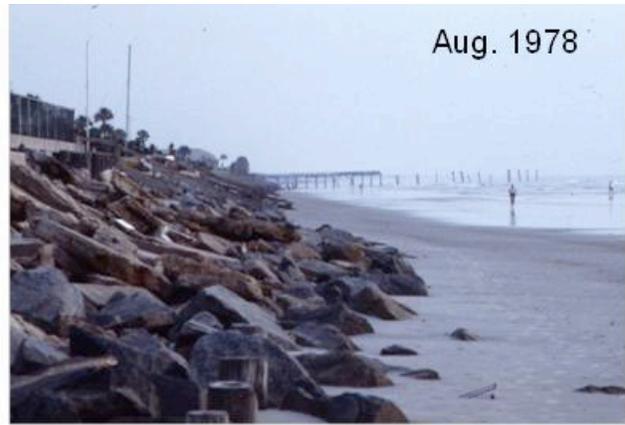
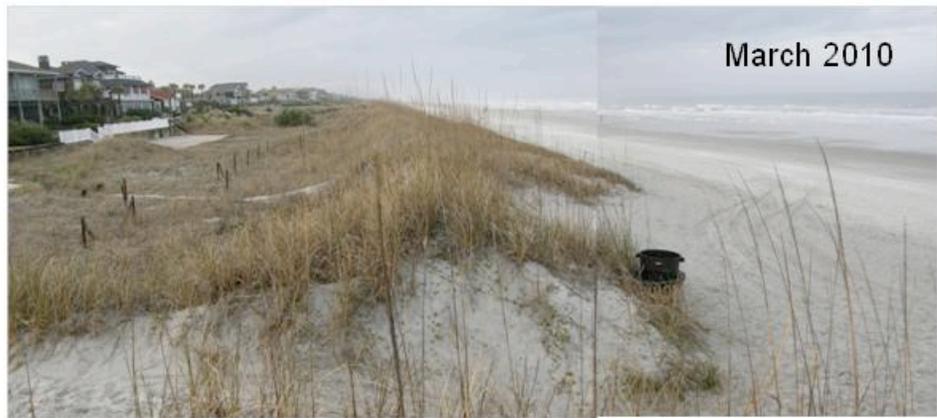
Figure G: Atlantic Beach, Florida prior to initial construction of the Federal Shore Protection Project <upper right and left> and in March 2010 <lower photo>. All photos illustrate conditions in Atlantic Beach.

Figures G through I visually compare beach conditions in Atlantic Beach and Jacksonville Beach in the early 1970's prior to project construction with those observed in 2010 and 2011. Project performance both visually and technically is outstanding.

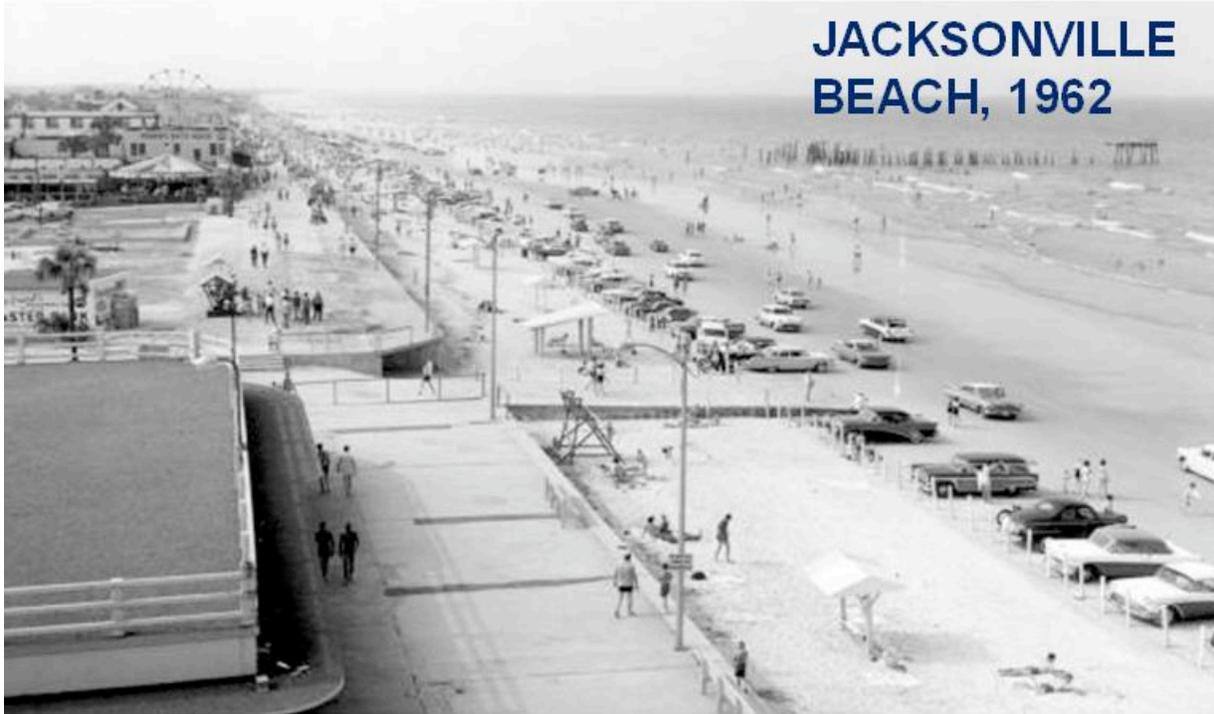
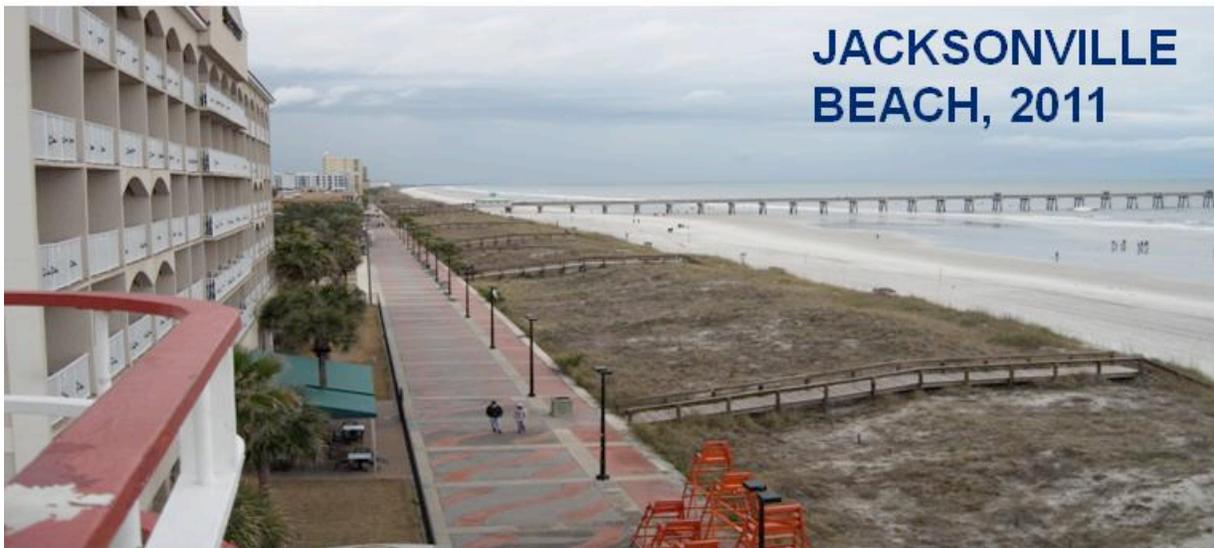
Figure H: Jacksonville Beach, Florida in 1962 prior to initial construction (and Hurricane Dora) <upper photo> and in February 2011 <lower photo>. Photos illustrate conditions in the vicinity of Beach Blvd. facing north.

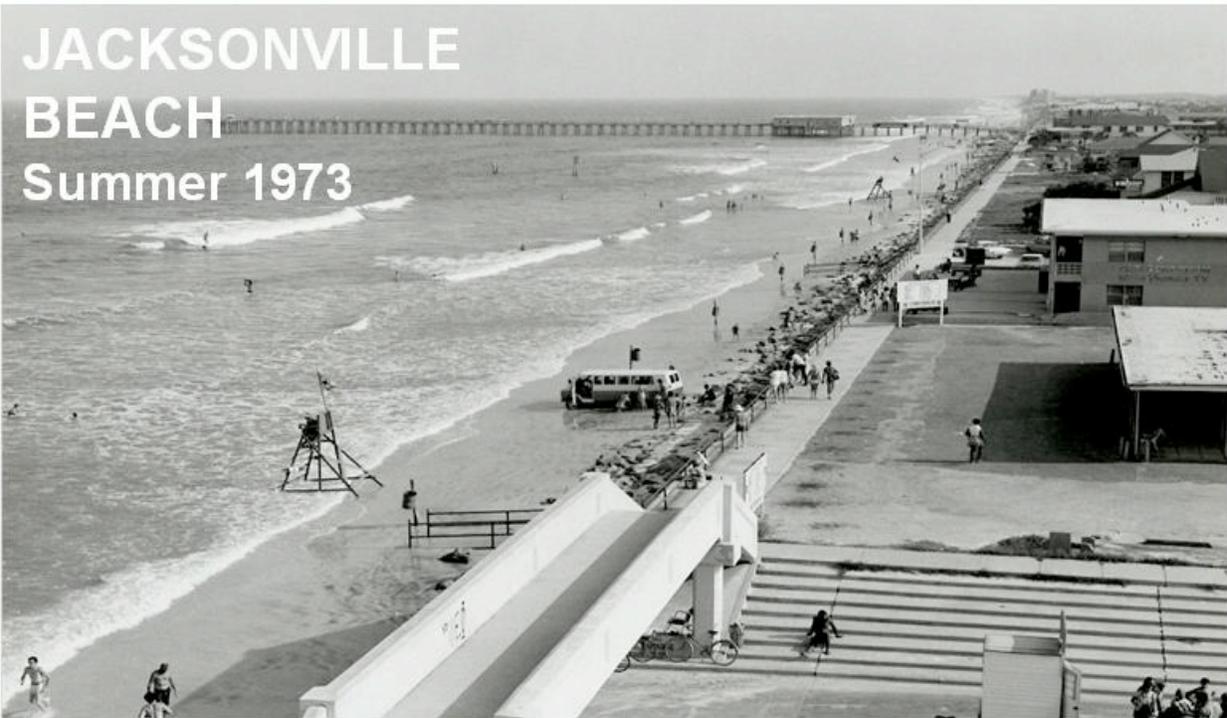
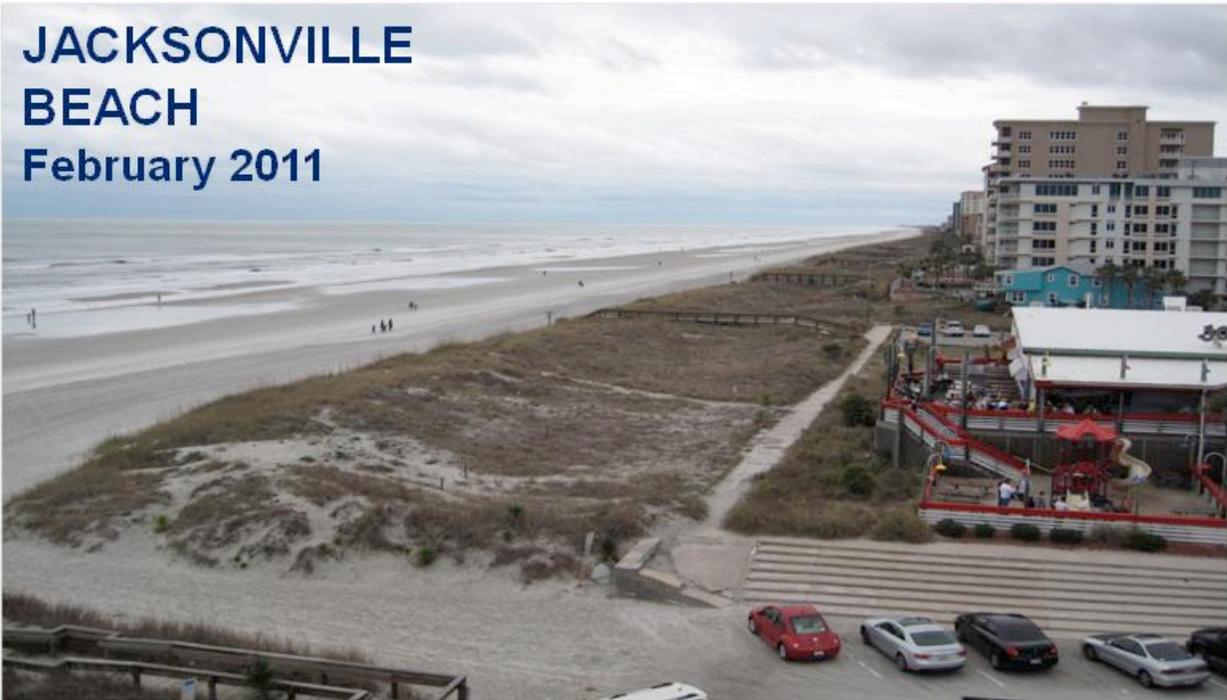
Figure I: Jacksonville Beach, Florida 1973, prior to initial construction <upper photo> and in February 2011 <lower photo>. Both photos illustrate conditions from atop the Lifesaving Corps Tower in Jacksonville Beach, facing south.
