IN-LINE FIBER OPTIC SENSING SYSTEM FOR PIPELINE CORROSION DETECTION

A Thesis
Submitted to the Graduate Faculty
of the
North Dakota State University
of Agriculture and Applied science

Major Department:
Civil and Environmental Engineering

March 2015

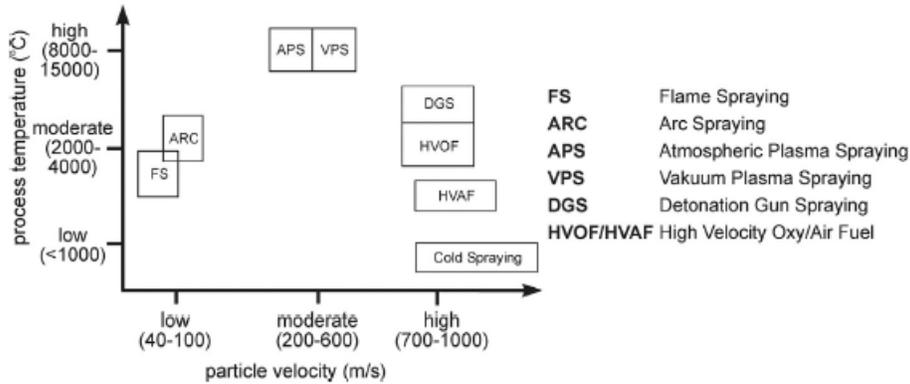
Figure 2. Spray Coating Process Temperature and Particle Velocity [56]

(HVOF), radio frequency (RF) plasma, or direct current (DC) plasma [55] as seen in Figure 2, which can be categorized by particle velocity and process temperature.

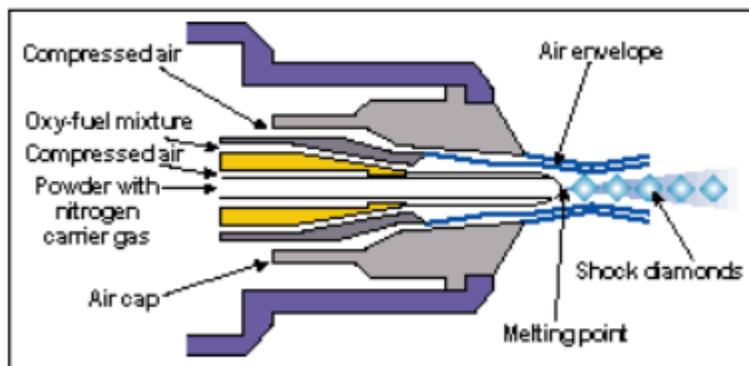
Figure 3. The HVOF Spraying Process [58]

Among all the thermal spraying techniques, the HVOF spray technique used widely [57]. The HVOF thermal spraying technique uses a spray gun that applies a combustion condition that mixes the oxygen and fuel to generate a gas stream with ultrasonic velocity as shown in Figure 3. Since the molten metal or powder is transported into combustion chamber of spray gun, the molten metal or powder particles are accelerated and combine with gas stream spray onto the surface of substrate via a converging-diverging nozzle. The splat impact each layer and form coating by the mechanical bonding [54].

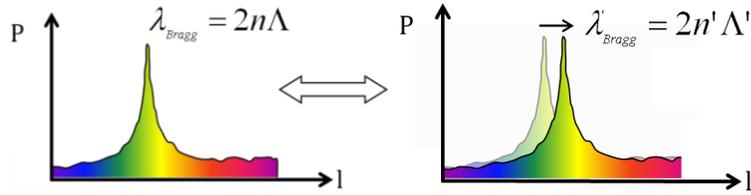
Figure 4. FBG Sensor Working Principle [60]

where, the P_e represents the photo-elastic constant of a fiber, which is related to the fiber property, ε is the strain on the fiber, ξ is a thermo-optic coefficient constant based on fiber property, and ΔT represents the temperature variation.

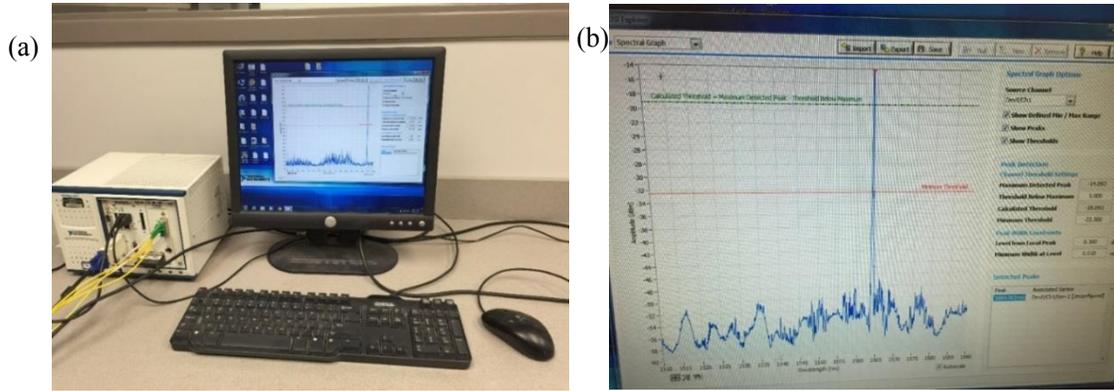
Figure 5. (a) Optical Spectrum Analyzer and (b) Typical FBG Spectrum

In this study, a National Instruments NI PXIe-1017 optical spectrum analyzer was used as shown in Figure 5(a) for the instrument to record the Bragg wavelength changes of the FBG sensors continuously and 5(b) for a typical FBG spectrum.

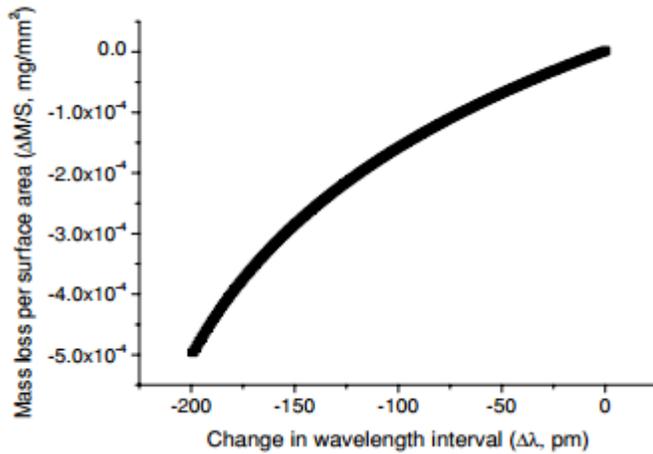
Figure 6. Wavelength Change versus the Mass Loss [65]

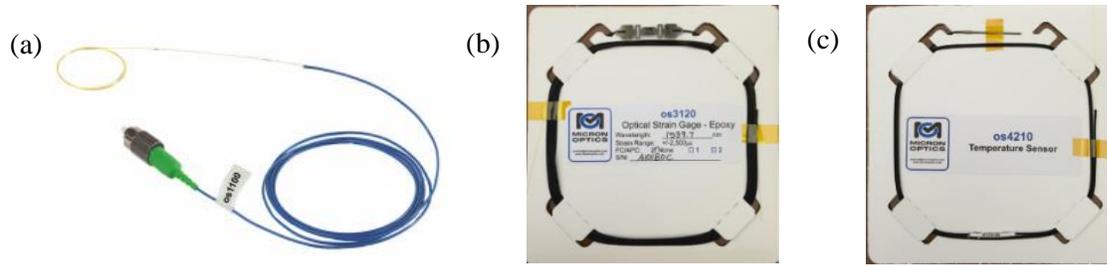
Figure 7. (a) The OS1100 Bare FBG Sensor, (b) The OS3120 Steel Packaged Sensor, and (c) The OS4210 Temperature FBG Sensor

The temperature sensor selected in this study is the OS4210 FBG sensor as shown in Figure 7(c), which is sealed by a stainless steel tube to protect the sensor and eliminate the strain effect. The OS4210 FBG sensor is used as a reference sensor that can compensate the thermal effect on FBG strain sensors. It has a temperature sensitivity of $10 \text{ pm}/^\circ\text{C}$ and the operating temperature range from -200°C to 275°C .

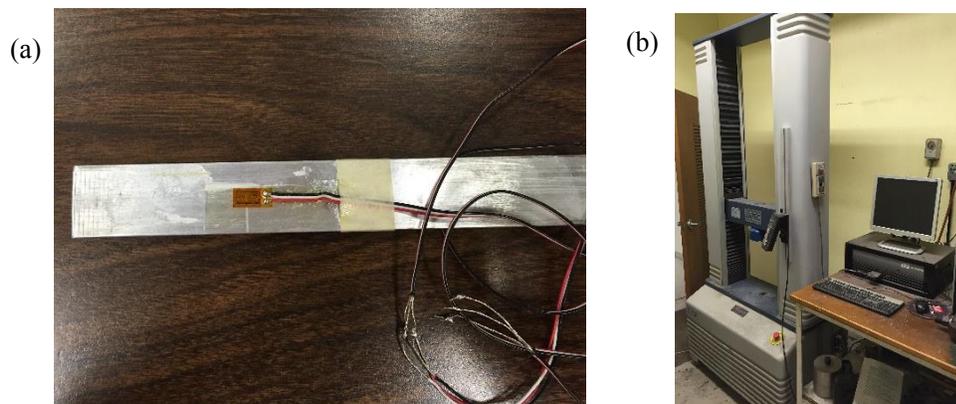
Figure 8. (a) Sample Used in Calibration Test and (b) SATEC Tensile Machine

Laboratory calibration tests were conducted in the Material Laboratory at the department of Civil and Environmental Engineering, NDSU, to validate the strain and temperature sensitivity of the selected FBG sensors. The OS1100 FBG strain sensor was attached on an aluminum bar together with one electrical resistant gauge for strain measurement calibration test as shown in Figure 8(a). The SATEC tensile machine as shown in Figure 8(b) had been used for the loading of the strain sensor calibration test.

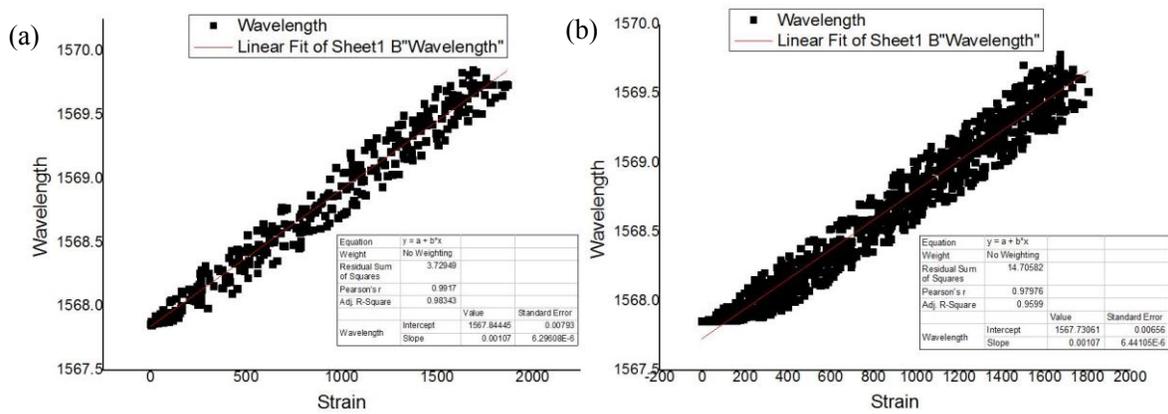
Figure 9. (a) Calibration Test Results at Loading Rate of 62.2 N/s and (b) Loading Rate of 17.8 N/s

Two calibration tests were operated with two different loading rates. The first test had a loading rate of 62.2 N/s, and a maximum load of 10 kN. The second test had a loading rate of 17.8

N/s, and the same maximum load of 10 kN. A personal computer was used to collect the strains detected by strain gauge and the wavelength changes from the FBG sensor was recorded using the NI PXIe-1017 optical spectrum analyzer. Figures 9(a, b) show the results of the two calibration tests, respectively. The obtained sensitivity of the FBG strain sensor is 1.07pm/με. Comparing the strain sensitivity provided on specification of the OS1100 FBG sensor of 1.2 pm/με, the sensor behavior is reasonable and within the tolerance range.

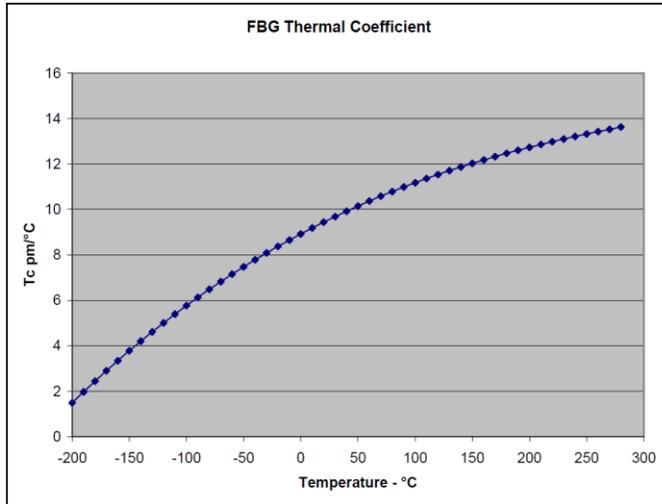
Figure 10. Temperature Calibration Test Results

The FBG temperature sensor was calibrated by placing the sensor into a temperature control chamber. The temperature changed from -200°C to 300°C. The FBG center wavelength changes were collected using the NI PXIe-1017 optical spectrum analyzer. Figure 9 shows the temperature calibration results. At room temperature, the OS4210 FBG temperature sensor has a temperature sensitivity of 9.5pm/ °C. It falls in the temperature sensitivity provided by manufacturer that is 10pm/ °C with a 1.7 pm/ °C tolerance, indicating a good sensor performance.

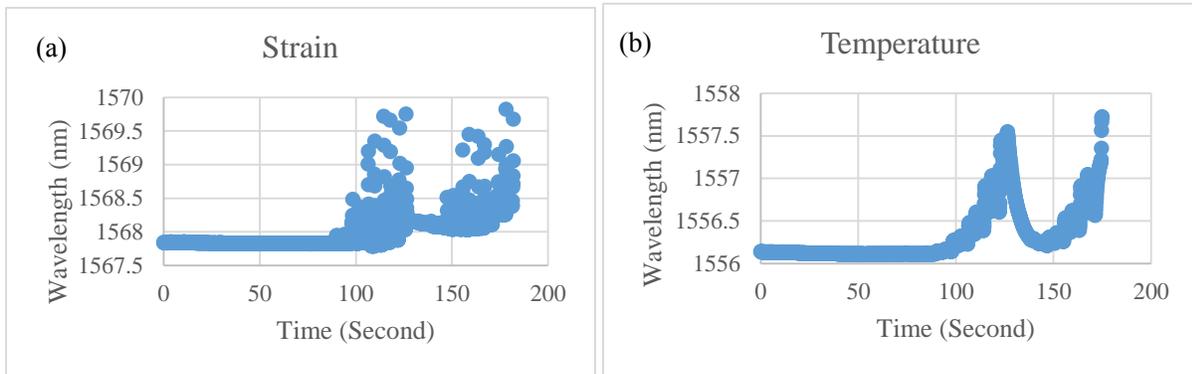
Figure 12. (a) Recorded Strain Sensor Data and (b) Temperature Sensor Data in First Test

Figures 12(a, b) show the recorded center wavelength changes of the OS1100 FBG strain sensor and the FBG temperature sensor. Two peaks of Bragg wavelength changes were notified on each sensor and no data were obtained after that. It indicates that after two horizontal rounds of automatic spraying through the coating process, the sensors failed. From Figure 11(b), it can be seen that the maximum temperature on the surface of substrate was detected around 150°C . With an operating temperature range up to 200°C , the FBG sensors were expected to survive the heat generated during the coating process.

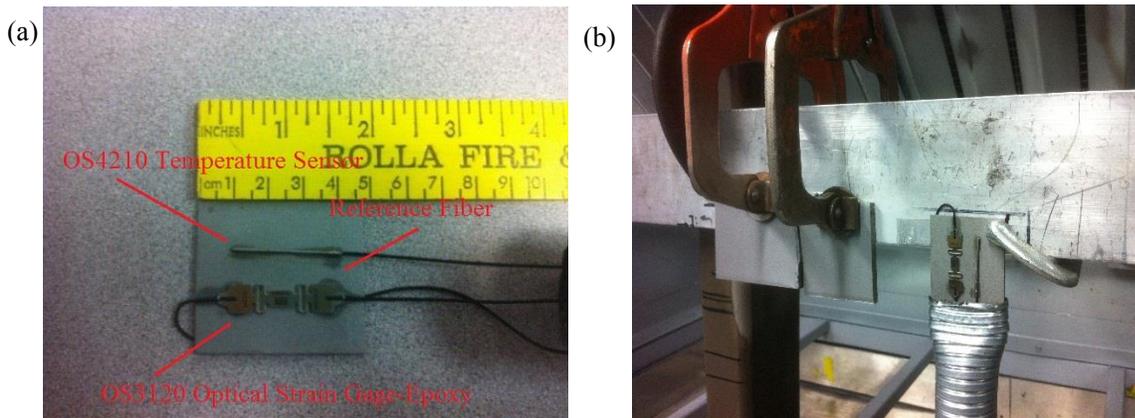
Figure 13. (a) Sensor Attached on a Steel Plate Using M-Bond 200 and (b) Sensor Embedment Test Set-up

spraying stream during HVOF process. One OS1100 FBG bare strain sensor, one OS3120 FBG steel carrier packaged sensor, and one OS4210 FBG temperature sensor were attached as shown in Figure 12(a). The M-Bond 200 epoxy was applied as the adhesive for the attachment, which is widely used to bond strain gauge on metal substrate. In addition, the communication fiber was protected in a flexible aluminum tube for protection as shown in Figure 13(b).

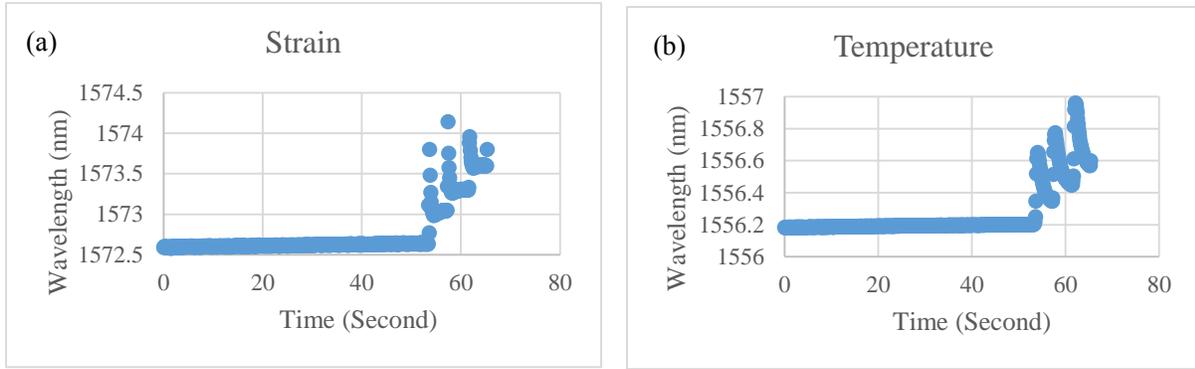
Figure 14. (a) Recorded Strain Sensor Data and (b) Temperature Sensor Data in Second Test

Figures 14(a, b) show the recorded center wavelength changes of the OS31200 packaged FBG strain sensor and the FBG temperature sensor during the thermal spraying coating process. Three peaks of Bragg wavelength changes were notified on each sensor and no data were obtained after that. It indicates that after three horizontal rounds of robotic spraying arm through the coating process, the sensors failed. The reading from the FBG sensors showed a maximum coating temperature of 75°C and the maximum strain of $1,000\mu\epsilon$ throughout the three rounds of spraying coating process. With an operational temperature above 150°C and a maximum strain limit of $2,500\mu\epsilon$, the FBG sensors could possibly survive.

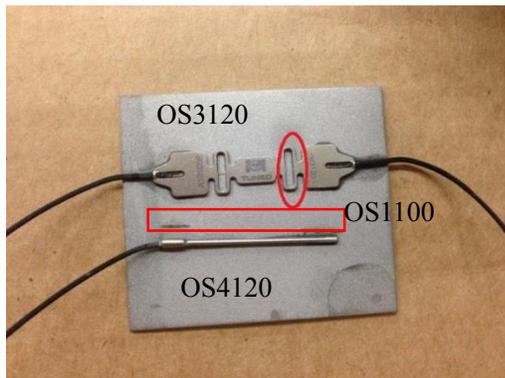
Figure 15. Damaged Area of the OS3120 FBG Sensor after the Second Trail

A visual inspection was performed for the testing sample after the failure of the second embedment test as seen in Figure 15. It is found that the bare fiber OS1100 FBG strain sensor was totally damaged by the spraying process and the steel carrier packaged OS3120 FBG sensor failed because of the small unprotected portion along the sensor was damaged by the high-velocity spraying stream. The OS4210 FBG temperature sensor was still in a good condition, however, no coating was bonded on the sensor. The absence of the coating may attribute to the smooth surface of the steel tube of the OS4210 sensor without sandblasting and the uneven surface with the substrate.

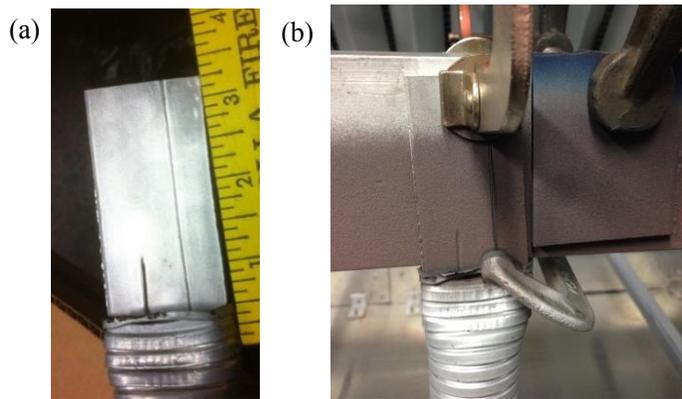
Figure 16. (a) Prefabricated Grooves on the Substrate and (b) Sensor Condition after Coating

were prefabricated on the substrate to have an even surface between the embedded sensor and the substrate, as shown in Figure 16(a). The hypodermic tube packaged OS1100 FBG strain sensor can be fully embedded inside the groove and half of the OS4210 FBG temperature sensor can be embedded inside the groove. The M-Bond 200 epoxy was applied on FBG sensors for the attachment purpose.

Figure 16(b) shows the sensor condition after 10 rounds of HVOF thermal spraying. Both FBG sensors showed positive trends for survival after the entire spray coating process. However, no coating was bonded on both sensors. The absence of the coating may attribute to the smooth surface of the tubes. In addition, with temperature rising significantly during the coating process, direct exposure of the hypodermic tube to the generated heat during the coating process induced significant buckling on the longitudinal direction of the tube. The strain sensor with limited dynamic range is not able to withstand such a numerous deformation and induced damage to the strain sensor. The findings from the third trail are summarized as below:

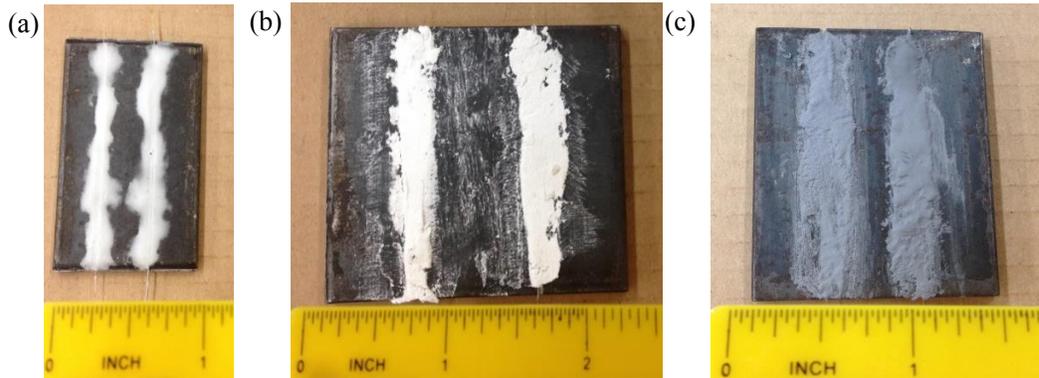
Figure 17. Samples with (a) Minco Epoxy, (b) Nickel Based Adhesive, and (c) Stainless-Steel Based Adhesive

eliminated for further testing. The two samples with Minco epoxy and stainless steel based adhesive were put forward for HVOF thermal spraying coating process using copper as a coating material.

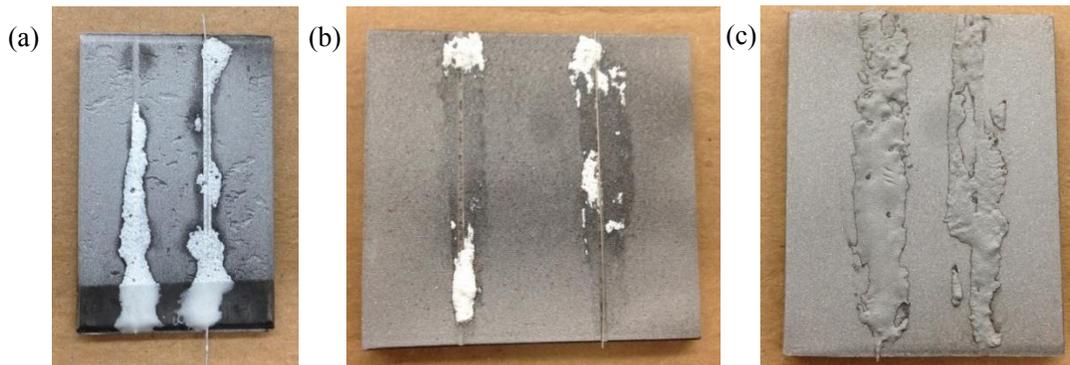
Figure 18. Samples with (a) Minco Epoxy, (b) Nickel Based Adhesive, (c) Stainless-Steel Based Adhesive after Sandblasting

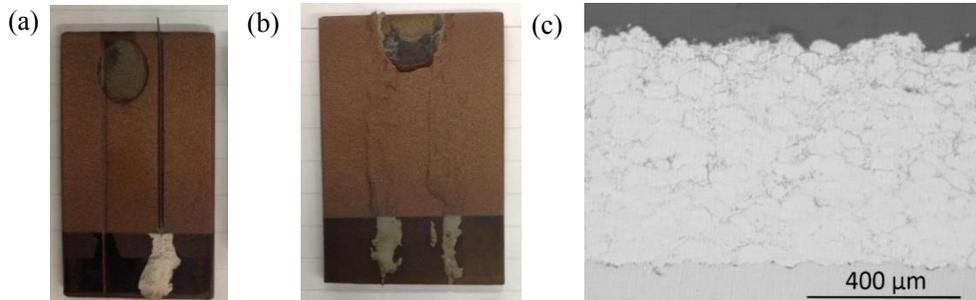
Figure 19. Samples with (a) Minco Epoxy, (b) Stainless-Steel Based Adhesive after Thermal Spray Coating process, and (c) Optical Micrograph of the Copper Coating

Figures 19(a, b) show the two samples after the HVOF thermal spray coating process. It can be seen from Figure 19(a) that the coating failed to be bonded on the Minco Epoxy after the spraying process. The hypodermic tube was exposed after the spraying process. On the other hand, the thermal sprayed copper coating was successfully bonded on sample with the metallic-stainless steel based adhesive as can be seen from Figure 19(b). A uniform coating of $800\ \mu\text{m}$ was

successfully deposited on the metallic-stainless steel based adhesive as shown in Figure 19(c) for the optical micrograph of the cross section of the coating.

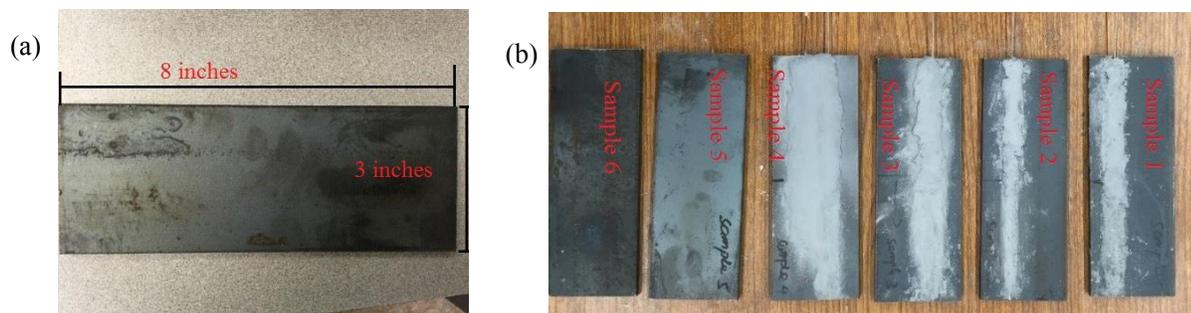
Figure 20. (a) Steel Plate Sample and (b) 6 Samples for Testing

of them had FBG sensors embedded among the six samples and the rest two were coating quality reference samples. Three of the samples with embedded sensors were designed to have one OS1100 FBG strain sensor on each sample and the other sample had both OS1100 FBG strain sensor and OS4210 FBG temperature sensor. As seen in Figure 20(b), the Sample #1 to Sample #3 had OS1100 sensor and Sample #4 contained both strain and temperature sensors. The Sample #5 and #6 were the reference samples for coating quality control purpose.

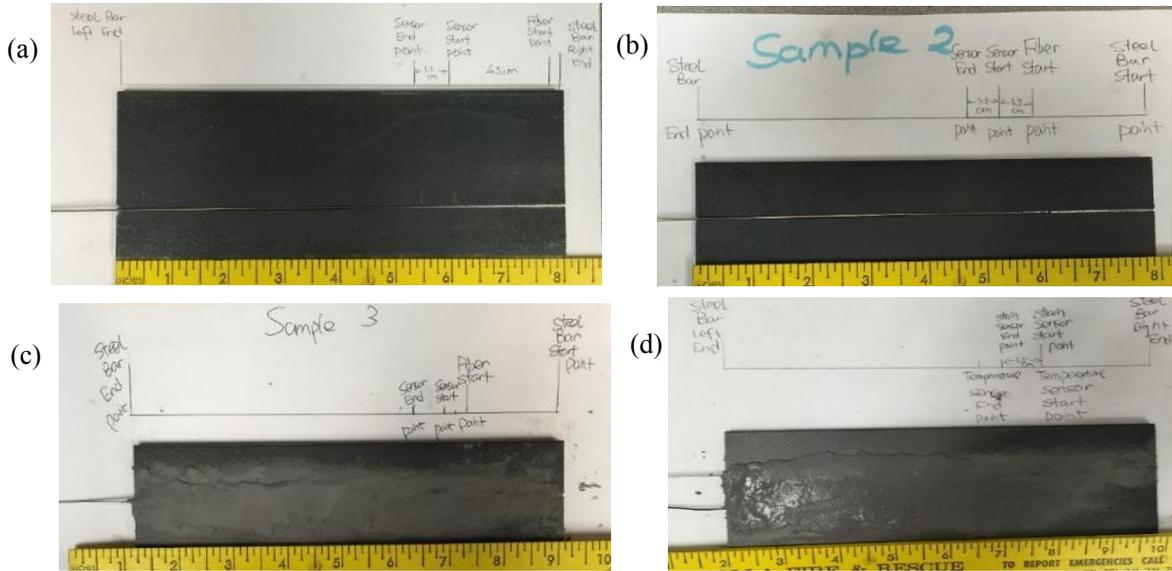
Figure 21. Sensor Location of Sample (a) #1, (b) #2, (c) #3, and (d) # 4

All the hypodermic tubes had been attached to the substrates using the Stainless-Steel Based Adhesive, which was approved to be successful surviving the thermal spraying process in Section 3.4. Figures 21 (a~d) show the sensor location on each samples. On Sample #4, the temperature sensor was parallel with strain sensor.

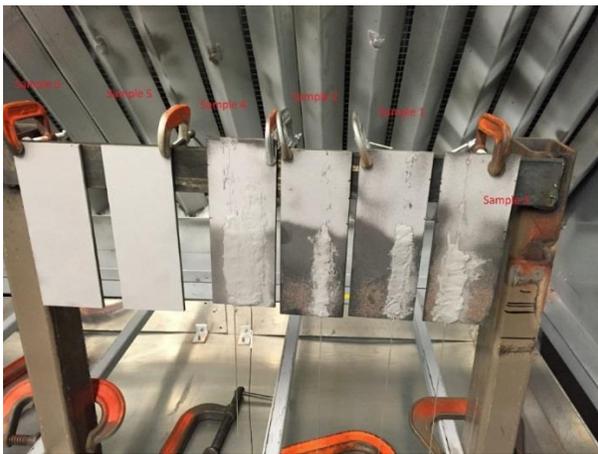
Figure 22. Sandblasted Samples

A 24-hour curing period was used for the Stainless-Steel Based Adhesive. Sandblasting were performed on all the samples as shown in Figure 22. The HVOF thermal spraying coating embedment was followed after sandblasting. The Aluminum Bronze Alloy (Al-Bronze, Sulzer Diamalloy 1004) Powder had been selected as the coating material in this test. It has a particle size of $45\mu\text{m}$ with a tolerance of $15\mu\text{m}$. Six thermal spraying rounds were performed using the robotic spraying arm for the coating process.

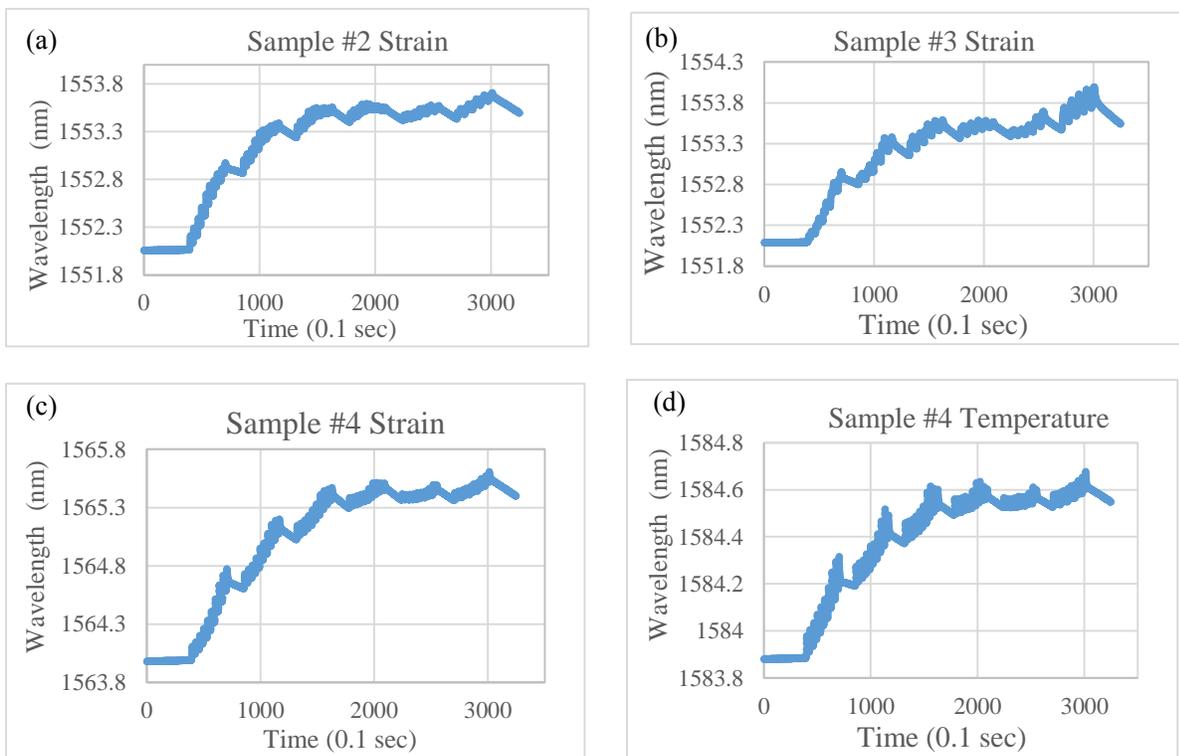
Figure 23. FBG Center Wavelength Changes during Coating Process for Sample (a) #2, (b) #3, (c) #4 Strain, (d) #4 Temperature

The wavelength changes of all the FBG sensors embedded in the samples along the thermal spraying coating process were collected using the NI PXIe-1071 optic spectrum analyzer continuously. Figures 23 (a~d) show the recorded FBG sensor center wavelength changes for Sample #2~#4 during the coating process. All the sensors successfully survived the thermal spraying coating process as seen in Figure 23 for the samples after coating. Six coating rounds were clearly demonstrated in all the sensor readings. With the temperature increases during the coating, all the sensors performed similarly with temperature changes. They are reasonable for this thermal spray coating process.

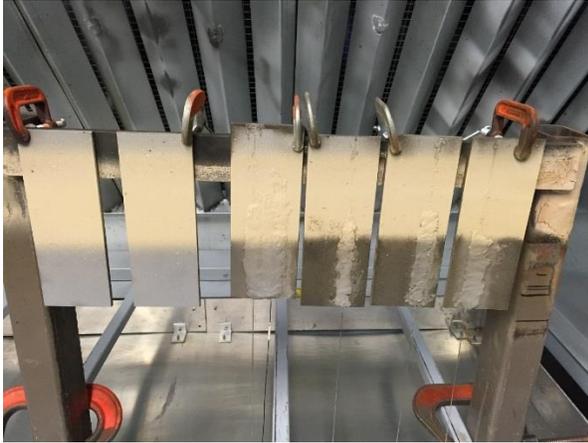
Figure 24. Thermal Spraying Coated Samples

The electrochemical accelerated corrosion test is performed by submerging the test samples in 3.5% NaCl solution as shown in Figure 24. In this study, to secure the 3.5% NaCl solution on the surface of coated samples, a PVC pipe was glued on top of each sample's coated surface. Loctite epoxy had been used to attach the pipe on the surface of the samples. The diameter of PVC pipe was 40.39 mm as shown in Figures 27. A 24-hour curing time in room temperature was used to allow the epoxy reaching its maximum strength.

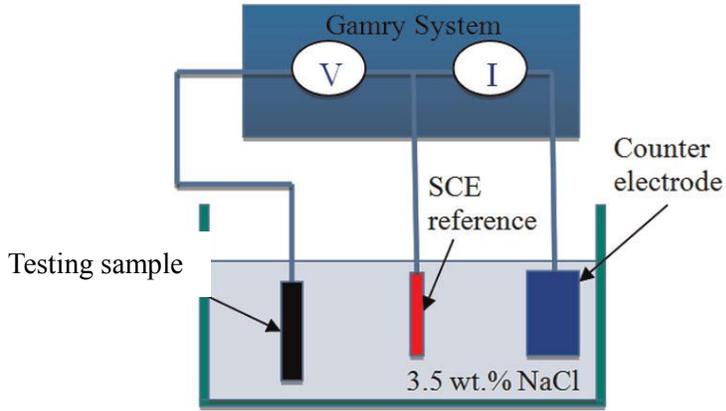
Figure 25. Electrochemical Reaction Principle

Electrochemical accelerated corrosion test as shown in Figure 25 generally is used to test the corrosion rate of the material in a short time period. The corrosion rate is determined by the equilibrium between opposing electrochemical reactions as described in Equations (1~2). One is the anodic reaction which releases electrons into metal and is oxidized. Another one is cathodic reaction which absorbs electrons from metal. Since the two reactions are in state of equilibrium, there is no electrical current flow occurs. The equilibrium potential assumed by the metal in the absence of electrical connections to the metal is called open circuit potential. It is the primary data should be detected in most of electrochemical corrosion test [55]. A stable open circuit potential reflect as a steady state of electrons exchange. Under the steady state, the corrosion reaction rate could be assumed as a constant. The value of either the anodic or cathodic current at open circuit potential generally is known called corrosion current, which is a critical characteristic to measure the corrosion rate.

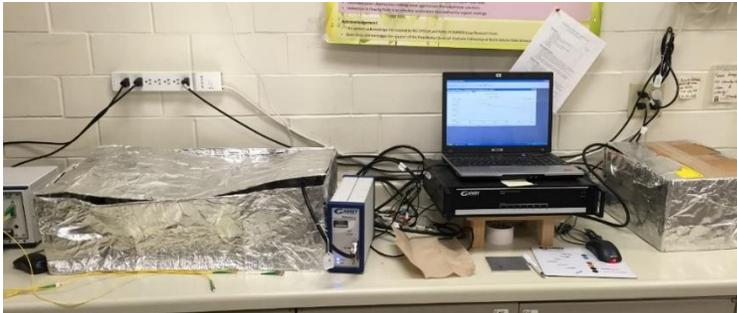
Figure 26. Accelerated Corrosion Test Set-up

In this study, a Gamry Reference 600 Potentiostat/Galvanostat/ZRA instrument, as shown in Figure 26, had been used to analyze the corrosion performance of the coated samples prepared in last chapter.

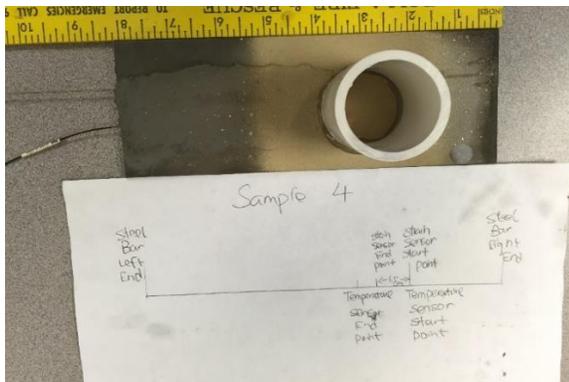
Figure 27. Glued Tube on the Sample Surface

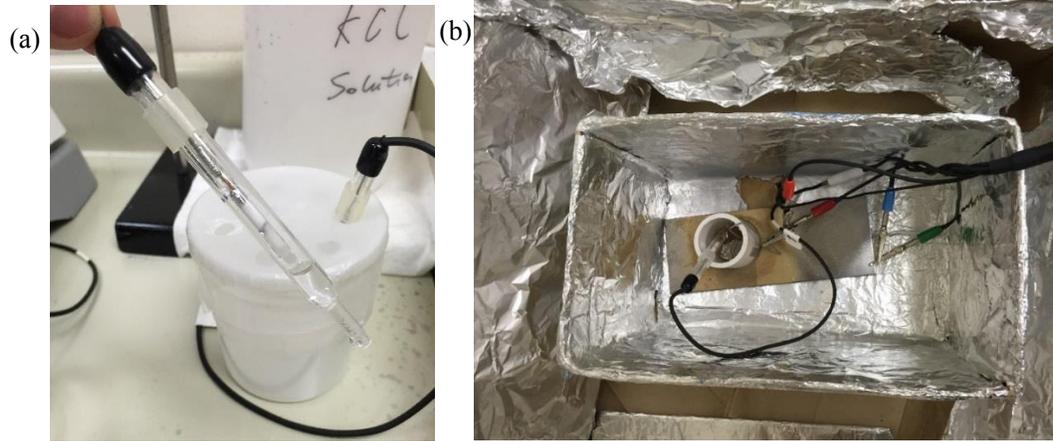
Figure 28. (a) Reference Electrode and (b) Accelerated Corrosion Test Set-up

With the samples prepared, 3.5% NaCl solution was added into the PVC pipes for electrochemical accelerated corrosion tests in an enclosed space. Six leads including two leads for electrodes, as seen in Figure 28(a), need to connect with the measurement equipment in a correct manner as shown in Figure 28(b) to perform the corrosion measurements. After connecting all leads to the sample, the polarization resistance test and open circuit potential test were performed. The equivalent weight of this coating material is 29.44 gram/equivalent, and the density is 4.1 gram/cm³. The area of the corrosion test had been performed which is the cross section area of

PVC pipe is 51.22 cm². The sample area, density, and equivalent weight were input into the instrument. All the test procedures followed the standard of ASTM G59 manual.

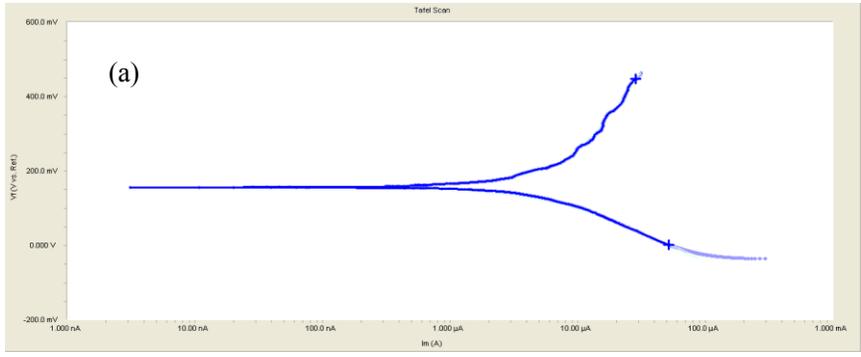
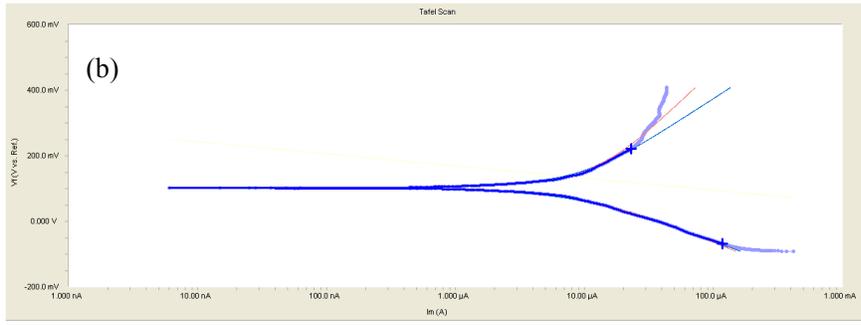
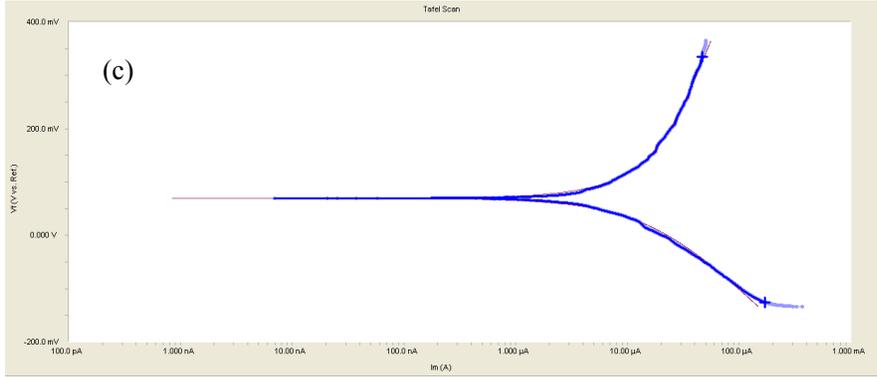
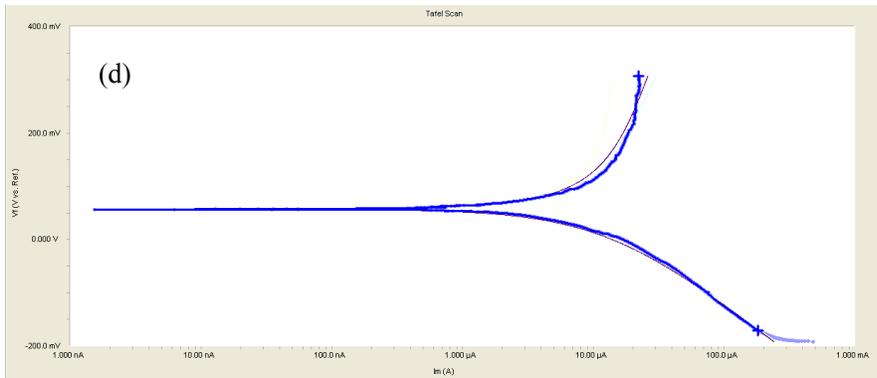
Figure 29. Tafel Test Result for Sample (a) #1, (b) #2, (c) #3, and (d) #4

The four coated samples with embedded sensors were tested using the procedures described above. With the polarization resistance, the Tafel tests were performed. Figures 29 (a~d) show the voltage (Y) change versus log-scale current (X) change for all the samples, respectively. The Tafel region contains the critical data, and the β_a and β_c will be calculated based on the data in the Tafel region.

Based on Figure 28, the β_a , β_c , and CR in Equation 5 and 10 had been calculated for all samples (generally the β_a varies from 0.06 to 0.12 V/decade, and the β_c varies from 0.06 to infinity) as shown in Table 3. An average corrosion rate of 0.3591 mill/year was obtained from the electrochemical method with a variance of 0.0958 mill/year. Compared to a regular carbon steel, which has a corrosion rate between 1~2 mill/year, a thin layer of thermal sprayed Al-Bronze Alloy coating material improved the corrosion resistance three times.

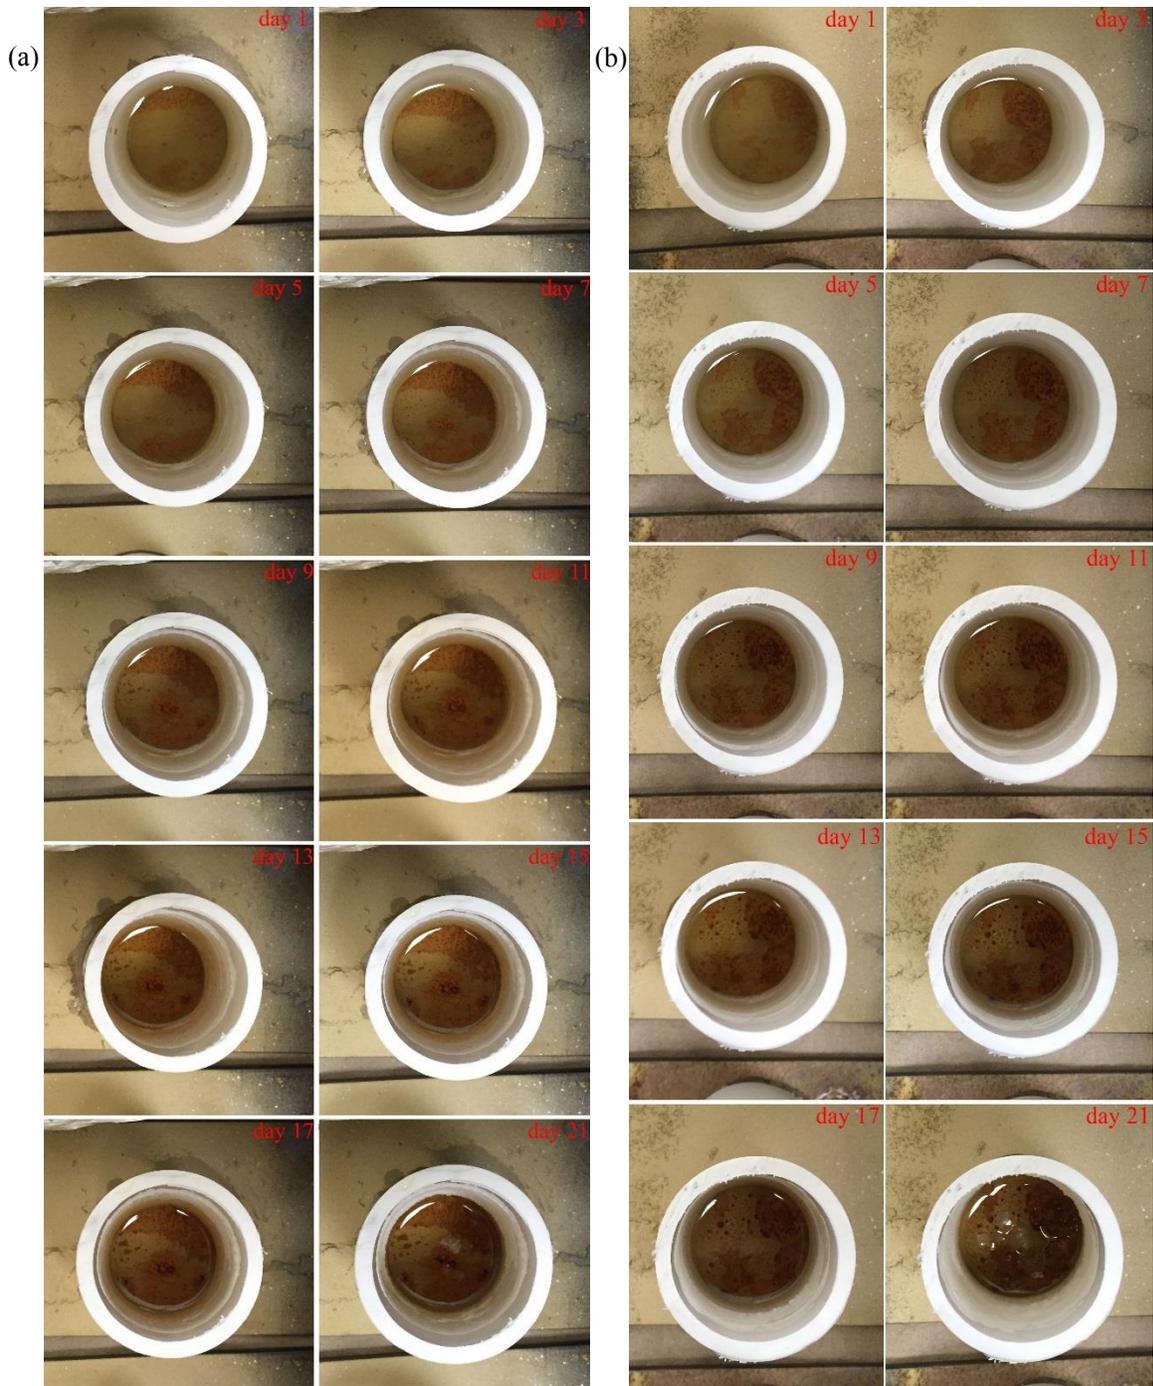
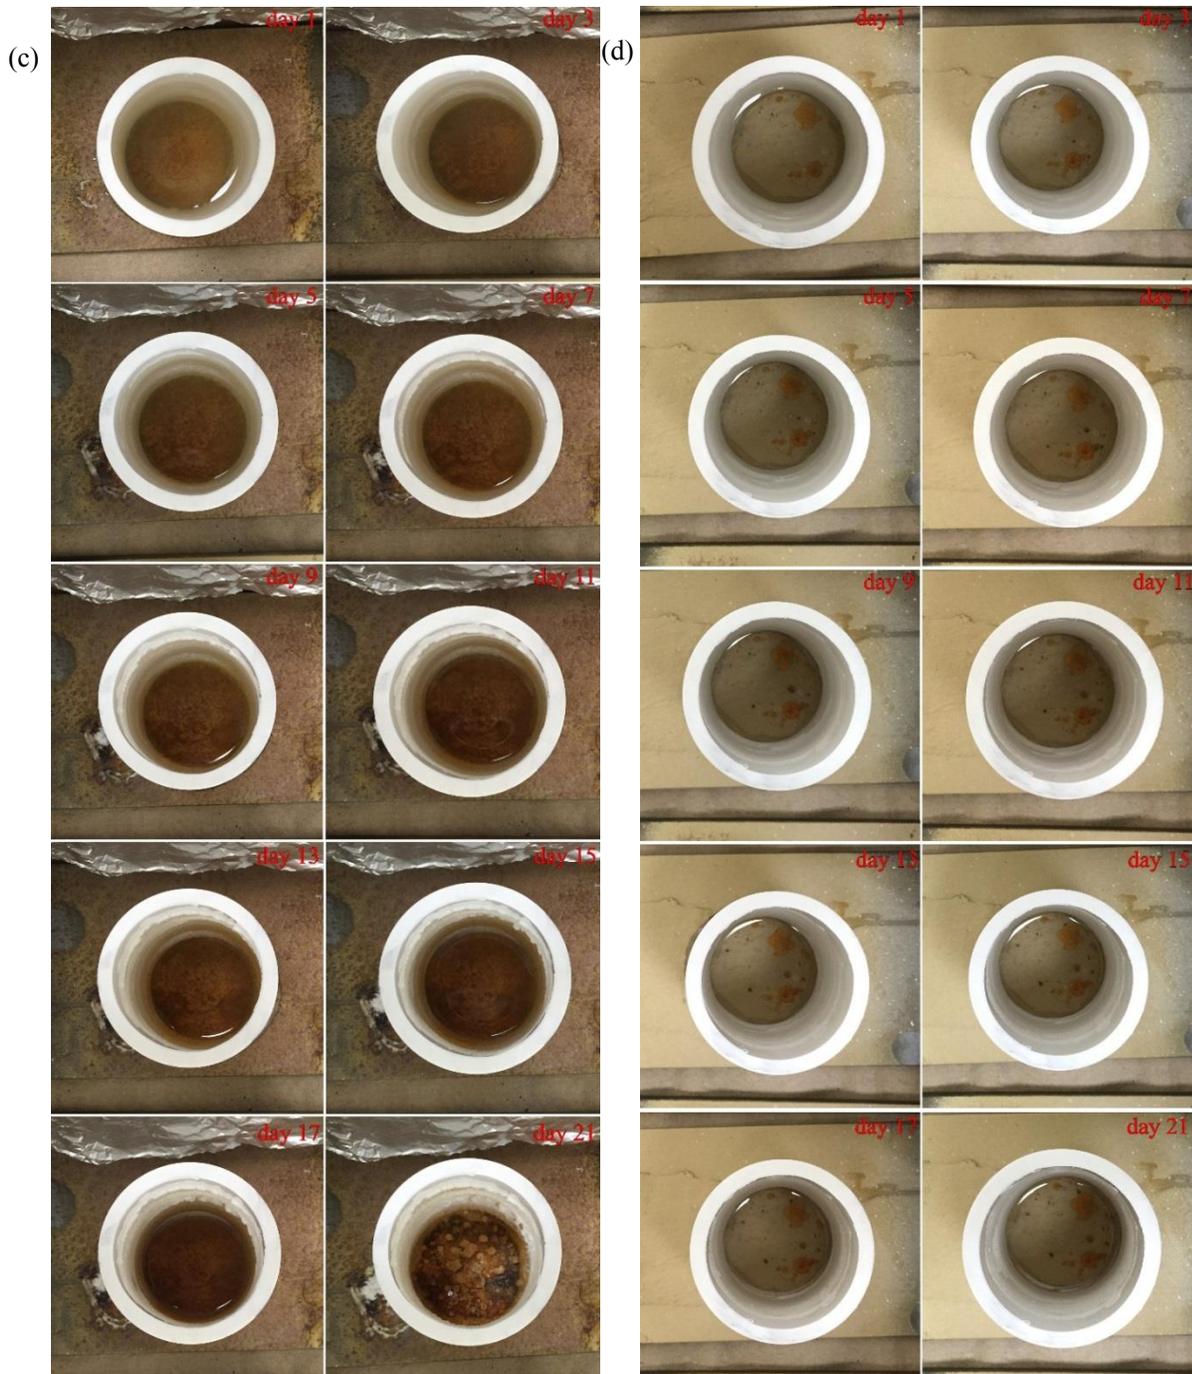
Figure 30. Corrosion visual inspection for Sample (a) #1, (b) #2, (c) #3, and (d) #4

Figure 30. Corrosion visual inspection for Sample (a) #1, (b) #2, (c) #3, and (d) #4 (continued)

Figures 30 (a~d) show the photos had been taken of each sample consistently during these 21 days for visual inspection. By comparing a sample each day from the photos, it is easily to figure out for Sample #1 and #2, the corrosion area was exactly above the embedded sensors. Since Sample #3 had been corroded before corrosion test, the corrosion area was larger than other samples. Sample #4 had less corrosion occurred which may be induced by a lower concentration of NaCl solution.

trend during the 21 days of corrosion test period. Sample #3 was corroded before the 7-day test as shown in the bottom inset in Figure 30 for the sudden drops of the wavelength changes. So no further monitoring was performed on Sample #3 after 7 days. A total changes of 60pm for Sample #2 and 30pm for Sample #1 and 4 were noticed from the test results. After 15 days, consistently, all the samples were corroded into the coating as can be seen from the bottom right inset of Figure 30.

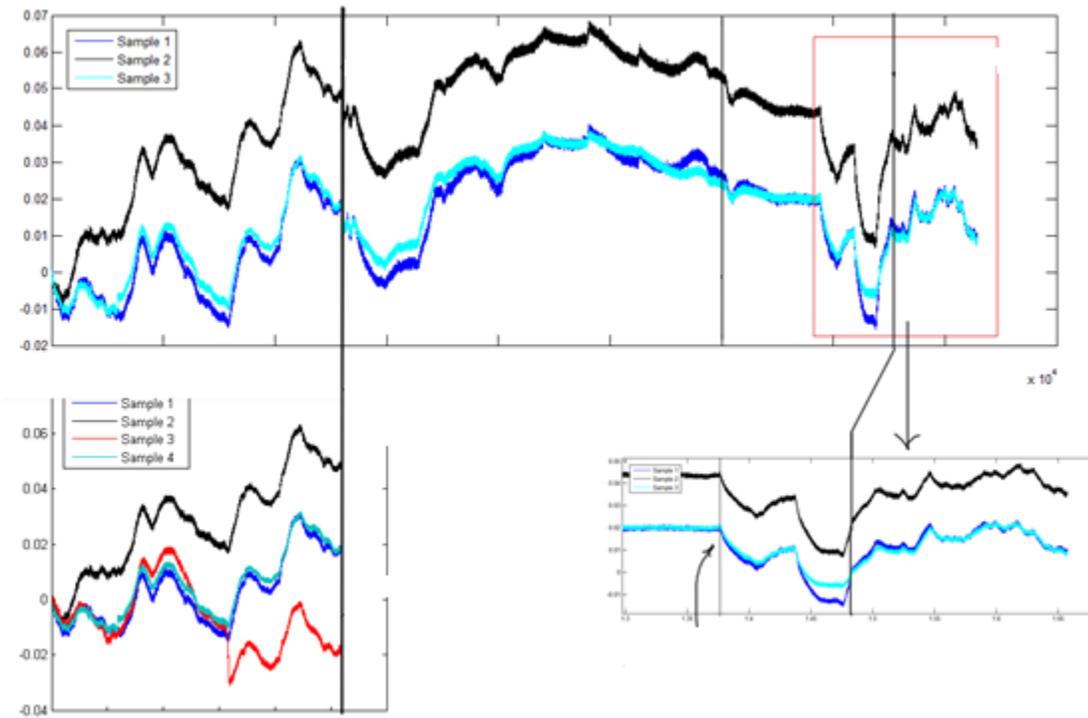
Figure 31. Center Wavelength Change from the FBG Sensors from the Accelerated Corrosion Test for 21 days
