# Study

**Events Associated with an Engine Malfunction**

**Thielert TAE 125 Engines**

**BEA**

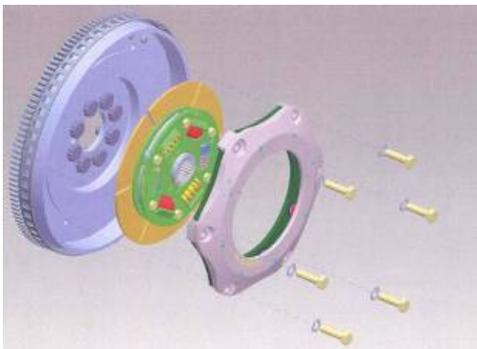
The table below describes the operation of clutches reference (P/N) 05-7211-K006002.

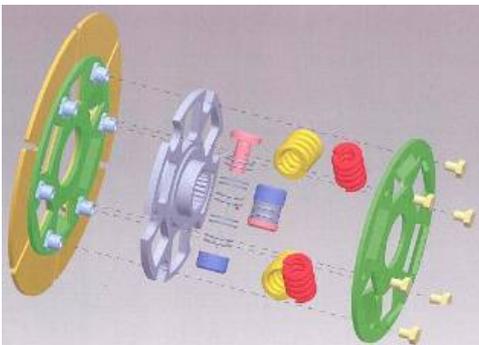
In addition to transmitting motion to the propeller, the role of the clutch system is to damp jolts associated with the operation of the engine:

- ❑ by sliding (at start-up and shutdown);
- ❑ by absorption (during operation) using springs and assemblies of Belleville washers. It operates on the same principle as an automobile clutch.

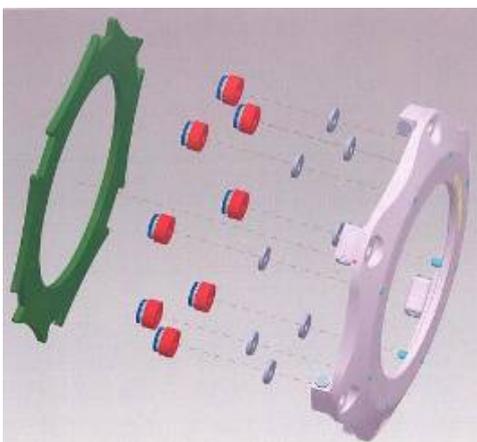
#### Clutch friction disk:

The disk drives the propeller via the reducing gears to which it is linked via a splined shaft. A preload is applied on the 4 springs. Two stacks of washers (in grey in the diagram) enable this preload to be adjusted. This pre-adjustment is carried out in the factory and cannot be modified by the user.

- either fractures of the clutch Belleville washers (F-HDAU and D-EAGB);
- or a fracture of a clutch spring (F-GUVX).

These fractures led to the clutch (P/N 05-7211-K000304) slipping and loss of propeller drive.

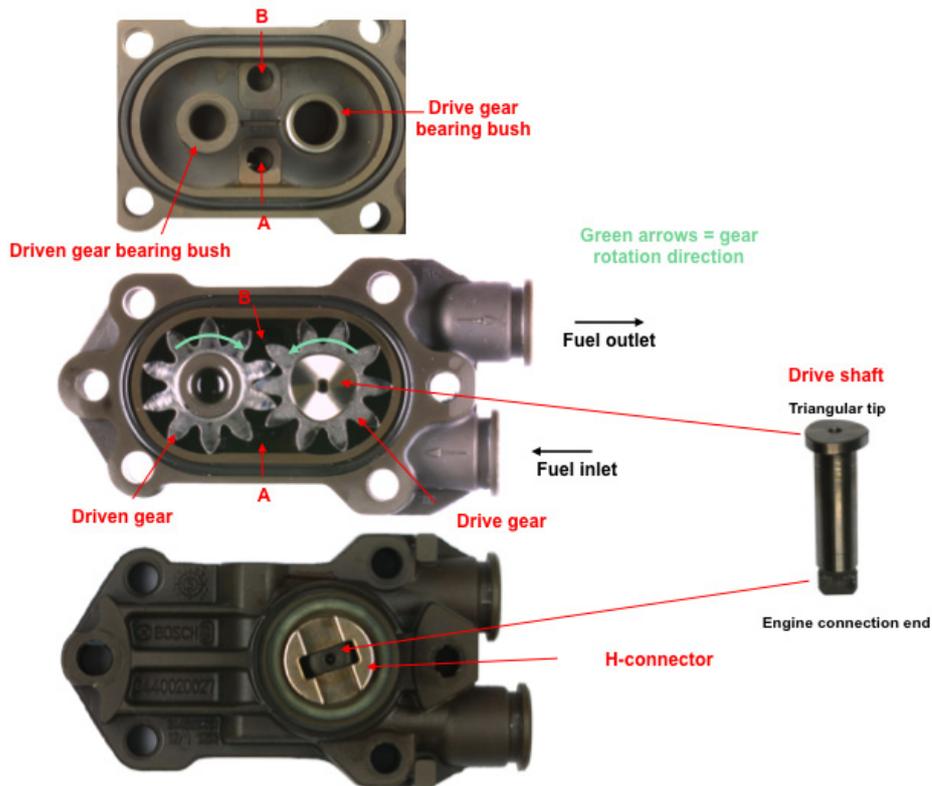
It is a mechanical geared pump, comprising a housing and two straight-toothed gears. The driving gear is linked in rotation to the drive shaft via castellations or a triangular tip depending on different versions. The drive shaft is driven by the engine, via an H-connector among others located outside the pump housing.

The fuel enters through feed inlet A, fills the tooth gaps and is thus conveyed, in the direction of the green arrows, towards discharge outlet B. Suction is created by the void caused when the teeth uncouple.

Pump failure was caused by the loss of rotational linking between the drive shaft and the driving gear. In this version of the pump, rotational linking is carried out by castellation. The shaft castellation, with sharp edges, wore down via friction the raised surface on the pump meant to receive the driving gear. This premature wear then generated play leading to wear on the shaft and driving gear castellation.

For these two events, pump failure was caused by the fracture of the driving gear. This fracture caused the drive shaft to block. The instant stopping of the shaft, while the connector was still driven, resulted in the sudden fracture of the H-connector and then engine shutdown.

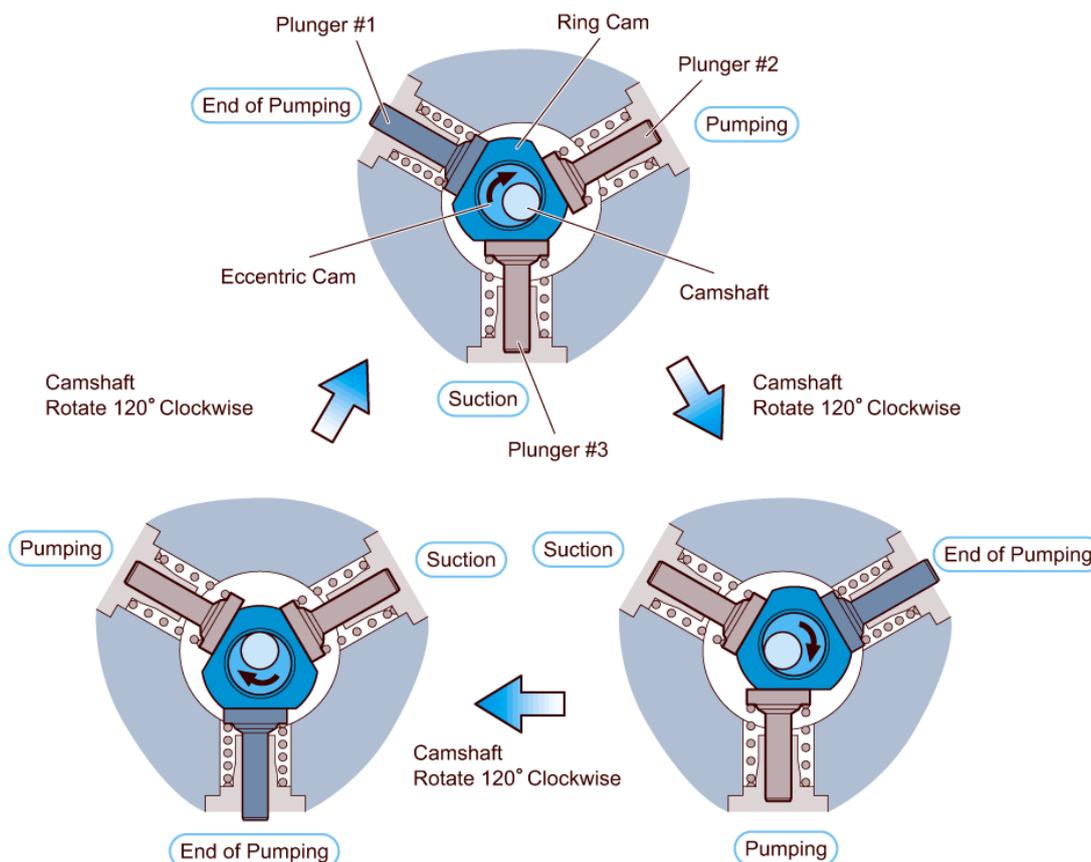
This is a three radial piston type pump, lubricated by fuel. It is driven by the engine using an eccentric camshaft. A triangular cam (ring cam on the scheme below, also called "polygon") comes into contact with the eccentric section via a bush. In normal operation, each flat side of the polygon is in contact with a piston: it is the camshaft's eccentricity that generates polygon movement and therefore compression of the pistons one by one.
